An Taisce
The National Trust for Ireland

Buildings at Risk

November 2014

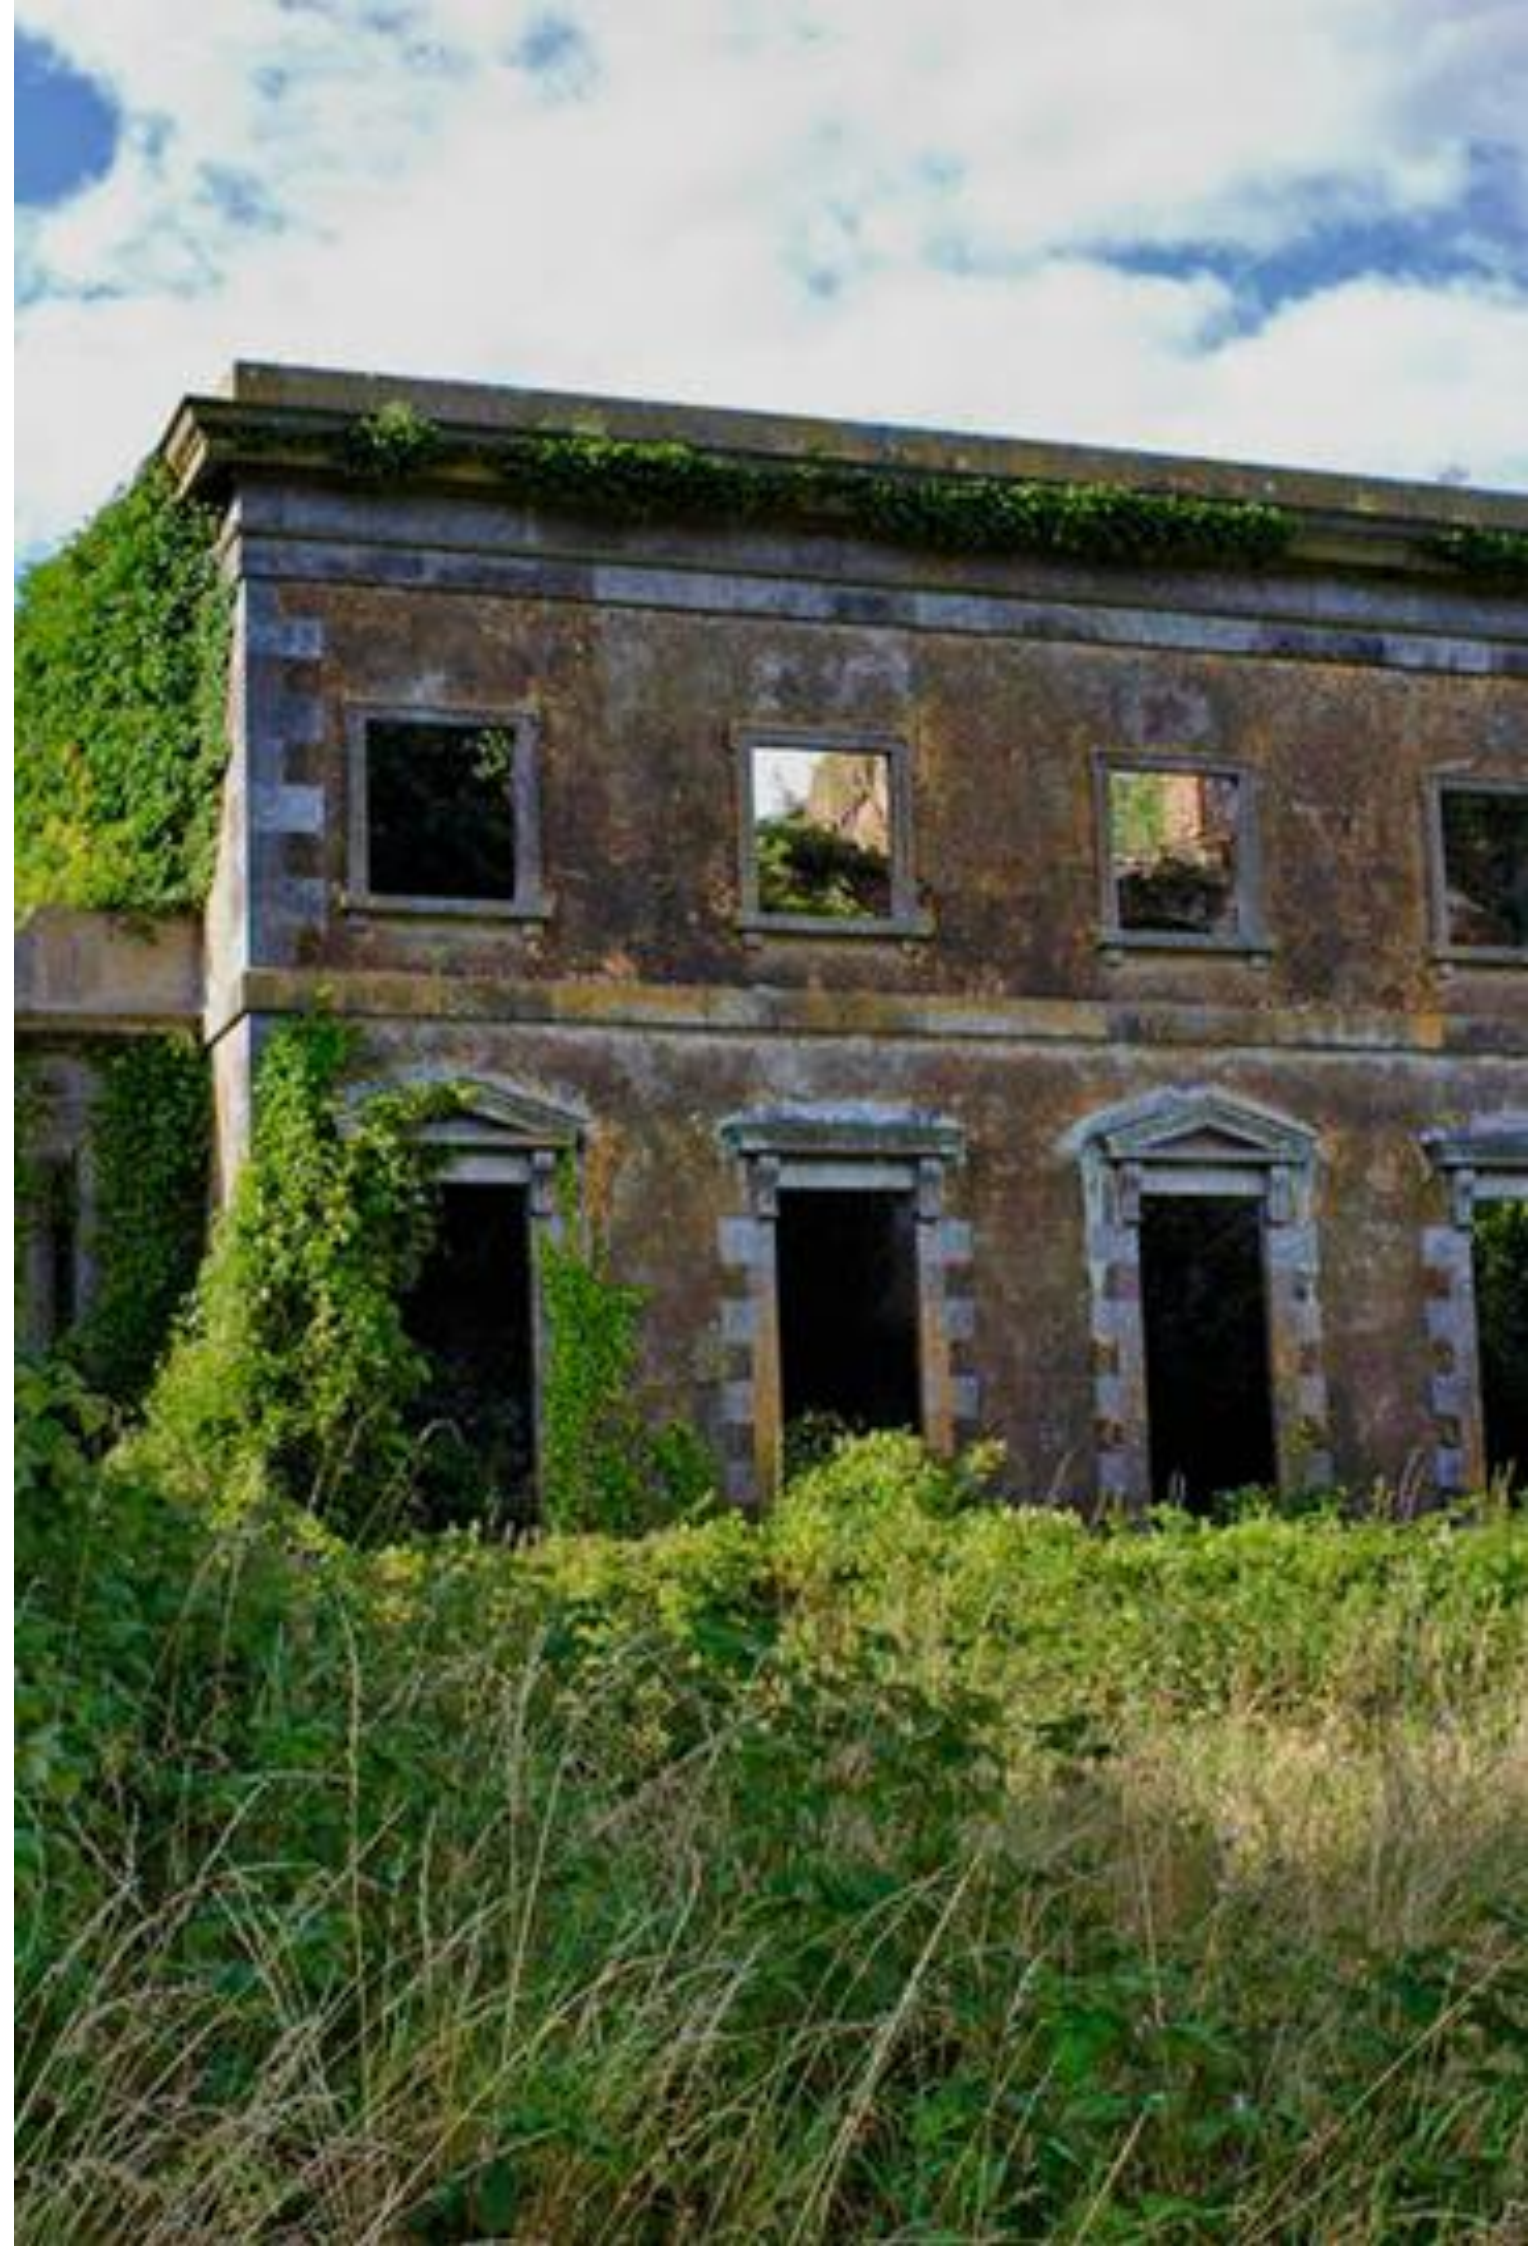
Block House

The building is a roofless shell. None of the original fabric remains other than the external walls. It is suffering from structural problems that could lead to full or partial collapse, and there is an immediate threat of further deterioration.

Dating from the 16th century with later alterations, it formed part of the defence of Kinsale Harbour together with James Fort and Charles Fort, located to the south-east. Significant conservation is required to prevent further deterioration of the structure which is constructed on a rock outcrop. The fortifications in Kinsale Harbour have the potential to become a large draw for tourism in the area.
